Bulletin 1800 5/2000 Page 1 of 6

What is Polybutylene Piping

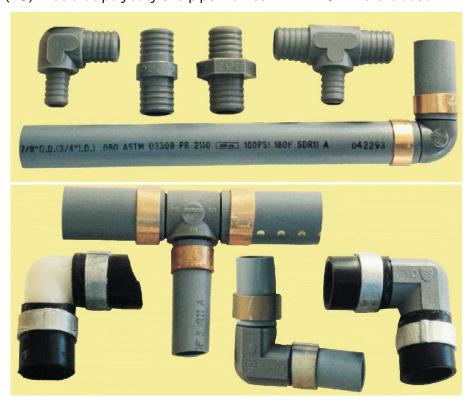
Polybutylene Pipe- Yard Service Line is typically blue (13), gray (14), or black (15). Inside Pipe is typically gray (14) or Black (15). Not that polybutylene pipe marked "PB 2110 M" is excluded.

Polybutylene pipe is usually gray or black plastic. The acetal inset fittings are usually gray and sometimes white. There are a variety of other fitting systems used with this type of pipe, but only pipe assembled with the fittings shown above are involved in the Spencer class action law suit. The Spencer class action suit encompasses Polybutylene pipe configured as shown in the above pictures. This type of pipe can be prone to pin holes or bursting. Normally this type of pipe is used for feed lines from the street source to the house. Some builders did use this pipe in the interior walls of homes, but it is rare. Check with a certified home inspector to determine if this pipe is in place.
